Re: Defect Information Report (FL411)

Defect Information Report (Section 573.6)

(c)(11) **Manufacturer's campaign number:** FL-411

The defect is contained in a component of some JOST- JSK 37 "U" Series Fifth Wheel Couplings. The defect has been identified as a fatigue crack that can initiate (under certain loading conditions) in the weld joining the mounting flange to the bracket pin (See figure 1 below). The recalled item is the bracket Pin. The bracket pin (Part Number SK 79011-03) is the component that joins the fifth wheel topplate to its mounting structure.

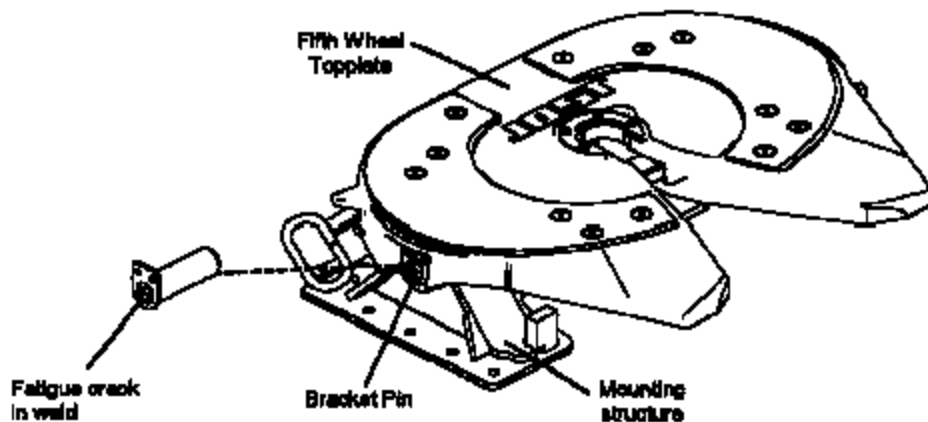
FIGURE 1

A fatigue crack can develop in the weld under certain loading conditions.

If left undetected or corrected it could lead to the separation of the fifth wheel topplate from its mounting structure.

The remedy is to replace the recall item with a pin of a new design. See figure 2 below. In addition to the difference in design, the recall item was painted black, while the new replacement pin is plated with Yellow Zinc Dichromate. This bright gold color plating should assist in readily identifying suspect units.
